BM8110
1994-99 BMW 318, 323, 325, & 328 I
Headliner Installation Aid
&
Headliner String Kit Installation Diagram

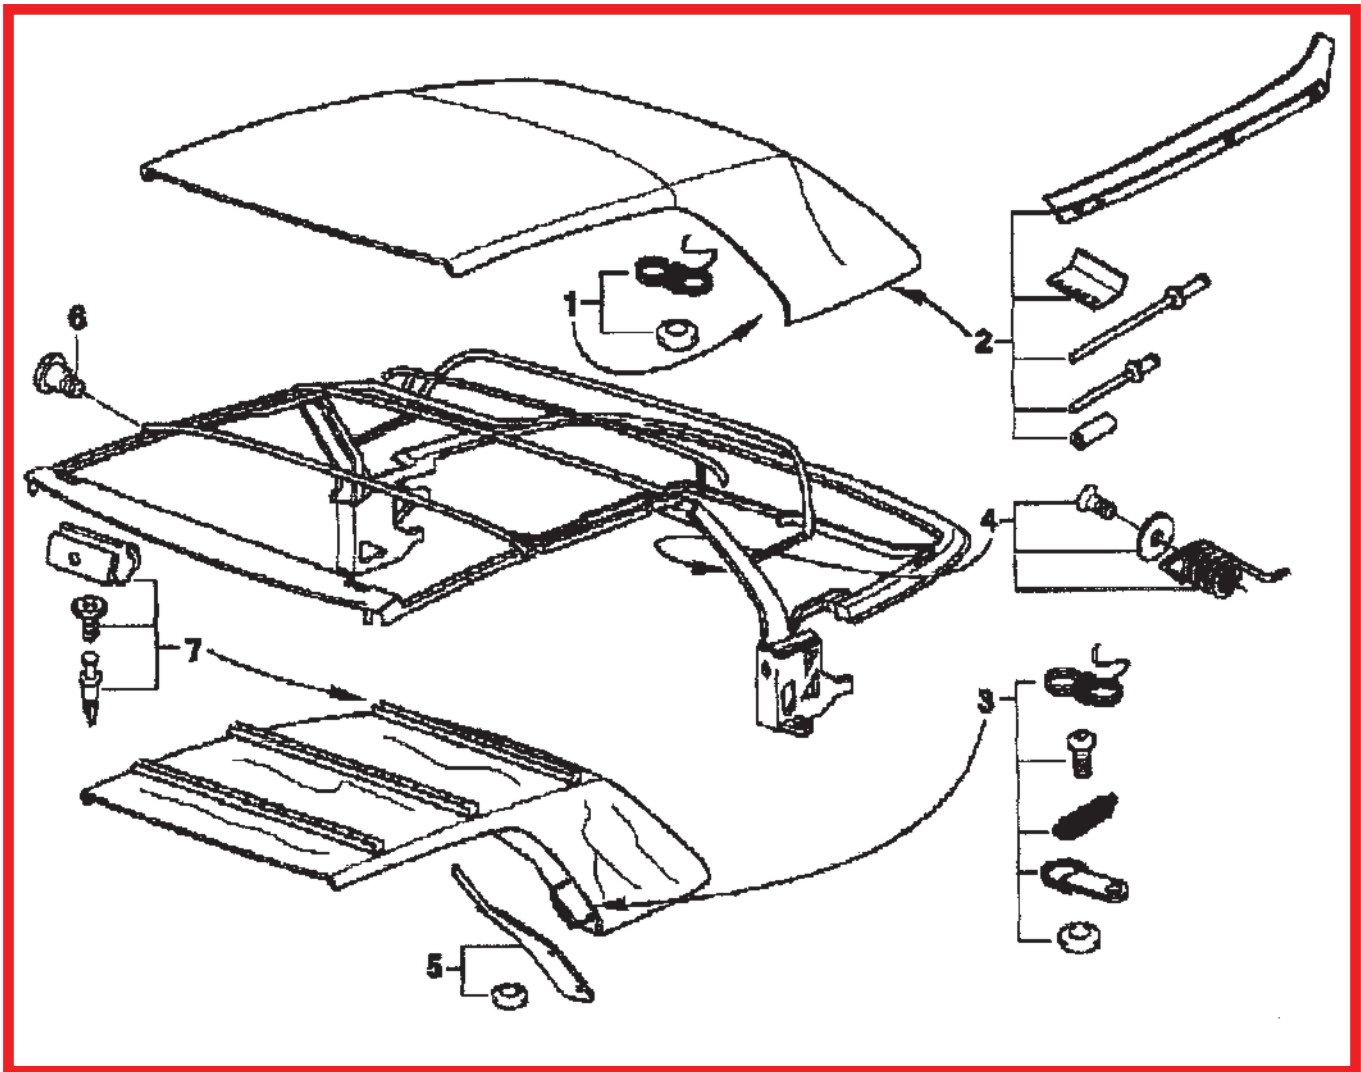
BMW headliners have been known to have problems with the "U" shaped overhead plastic bow channels. Occasionally it slips off the bow after installation.

The manufacturer of the headliner recommends installing pop rivets or screws through the "U" shaped plastic into the metal bows. Using 2-3 pop rivets or screws per bow should be sufficient in preventing the plastic from slipping off of the bow.
